Cap Inspection Report for the Former Pacific Electric Motors Facility, 1009 66th Avenue, Oakland, California

This letter documents the condition of the cap located at the Site based on the inspection that was conducted by Mr. Wayne Hung of ARCADIS on January 17, 2015. During the inspection, the surface of the cap was visually inspected and photographed for the following criteria:

February 2, 2015

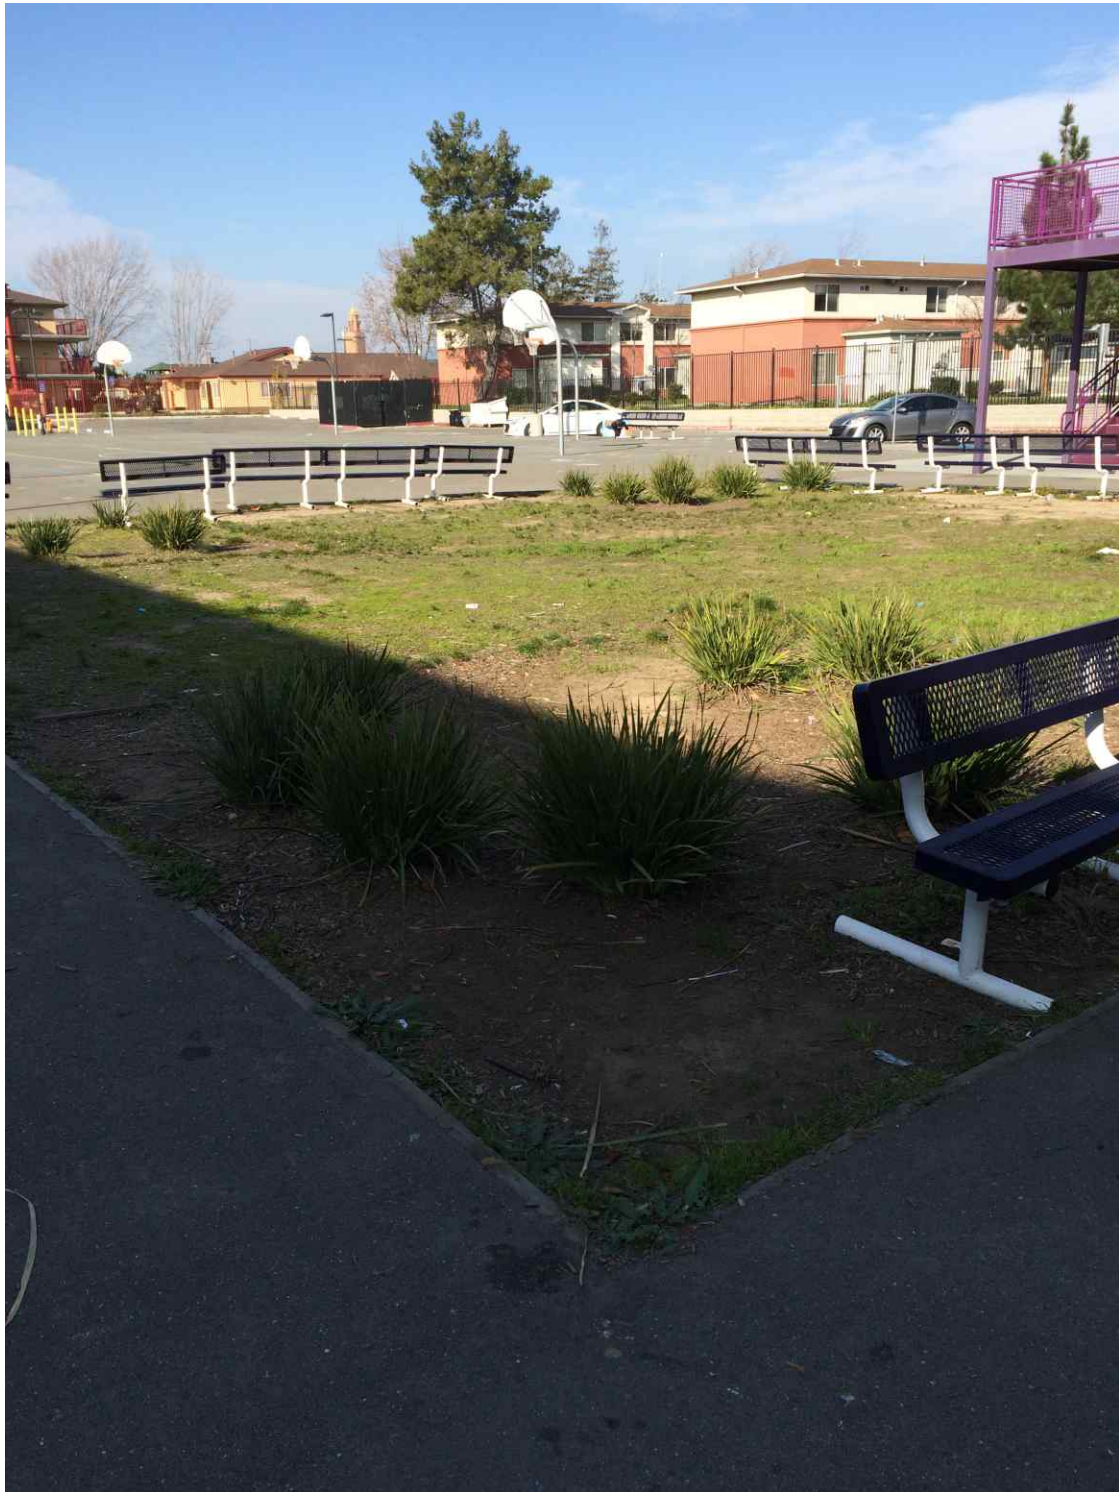
FIGURE
B-14

Landscaped-Planter and and Pedestrian Walkway Area Near the Rear
of the Site

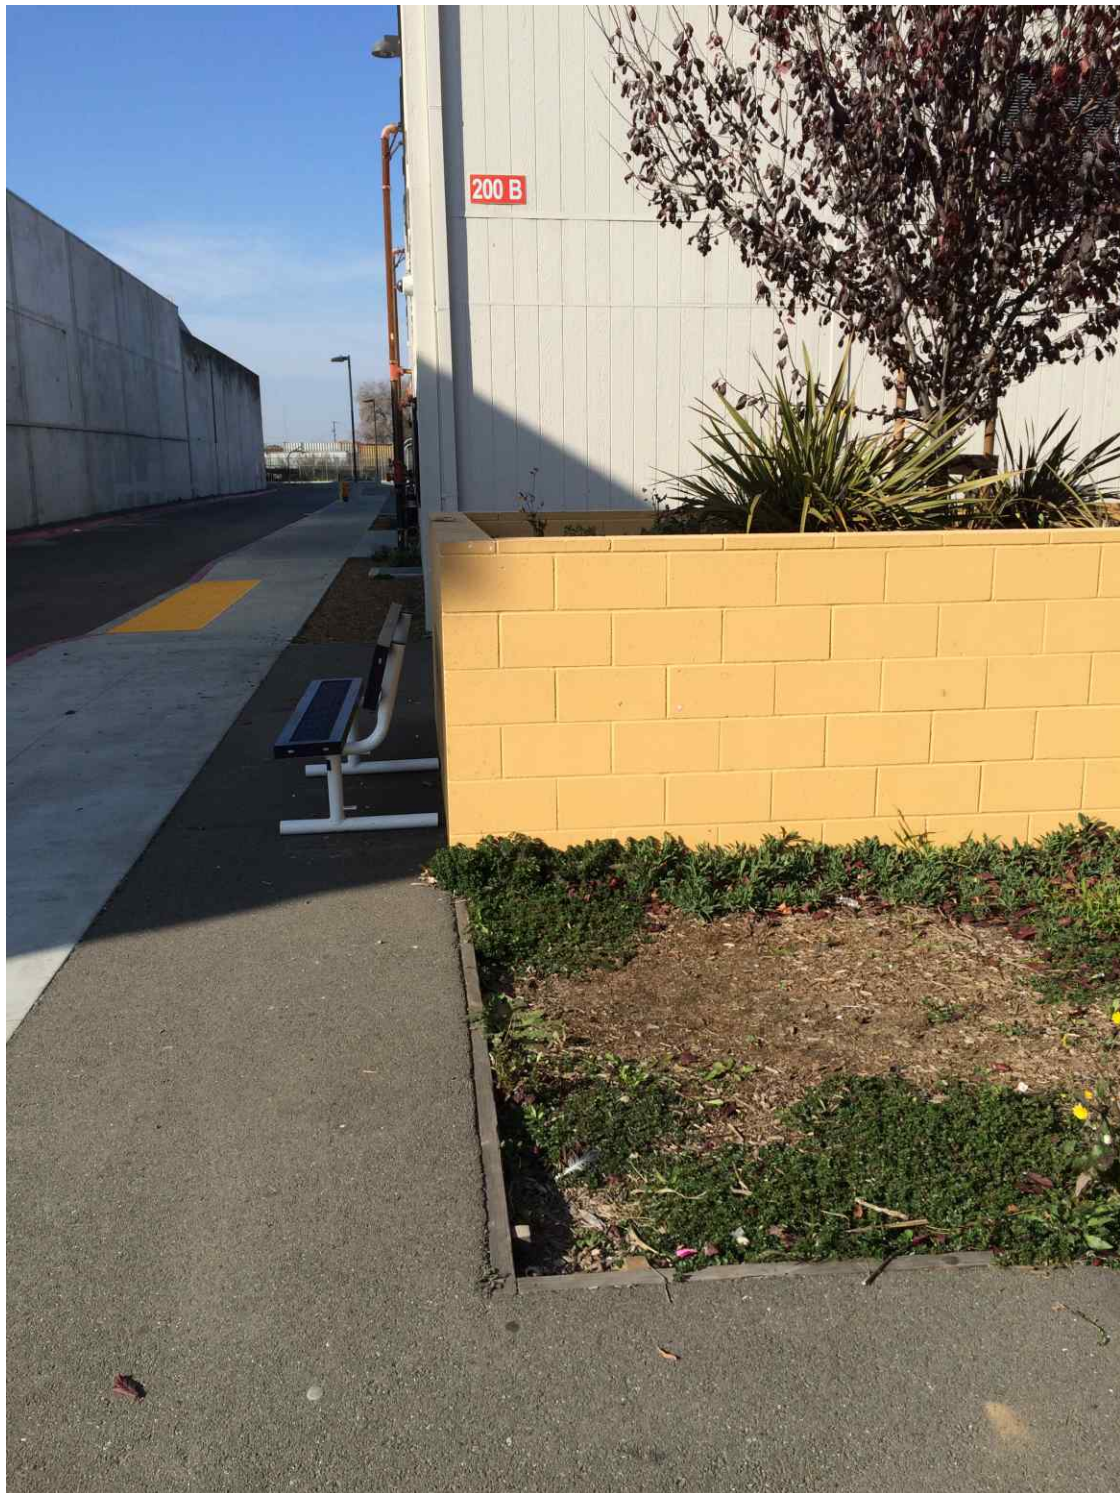
FIGURE
B-15

Landscaped-Planter and Pedestrian Walkway Area Near Classroom

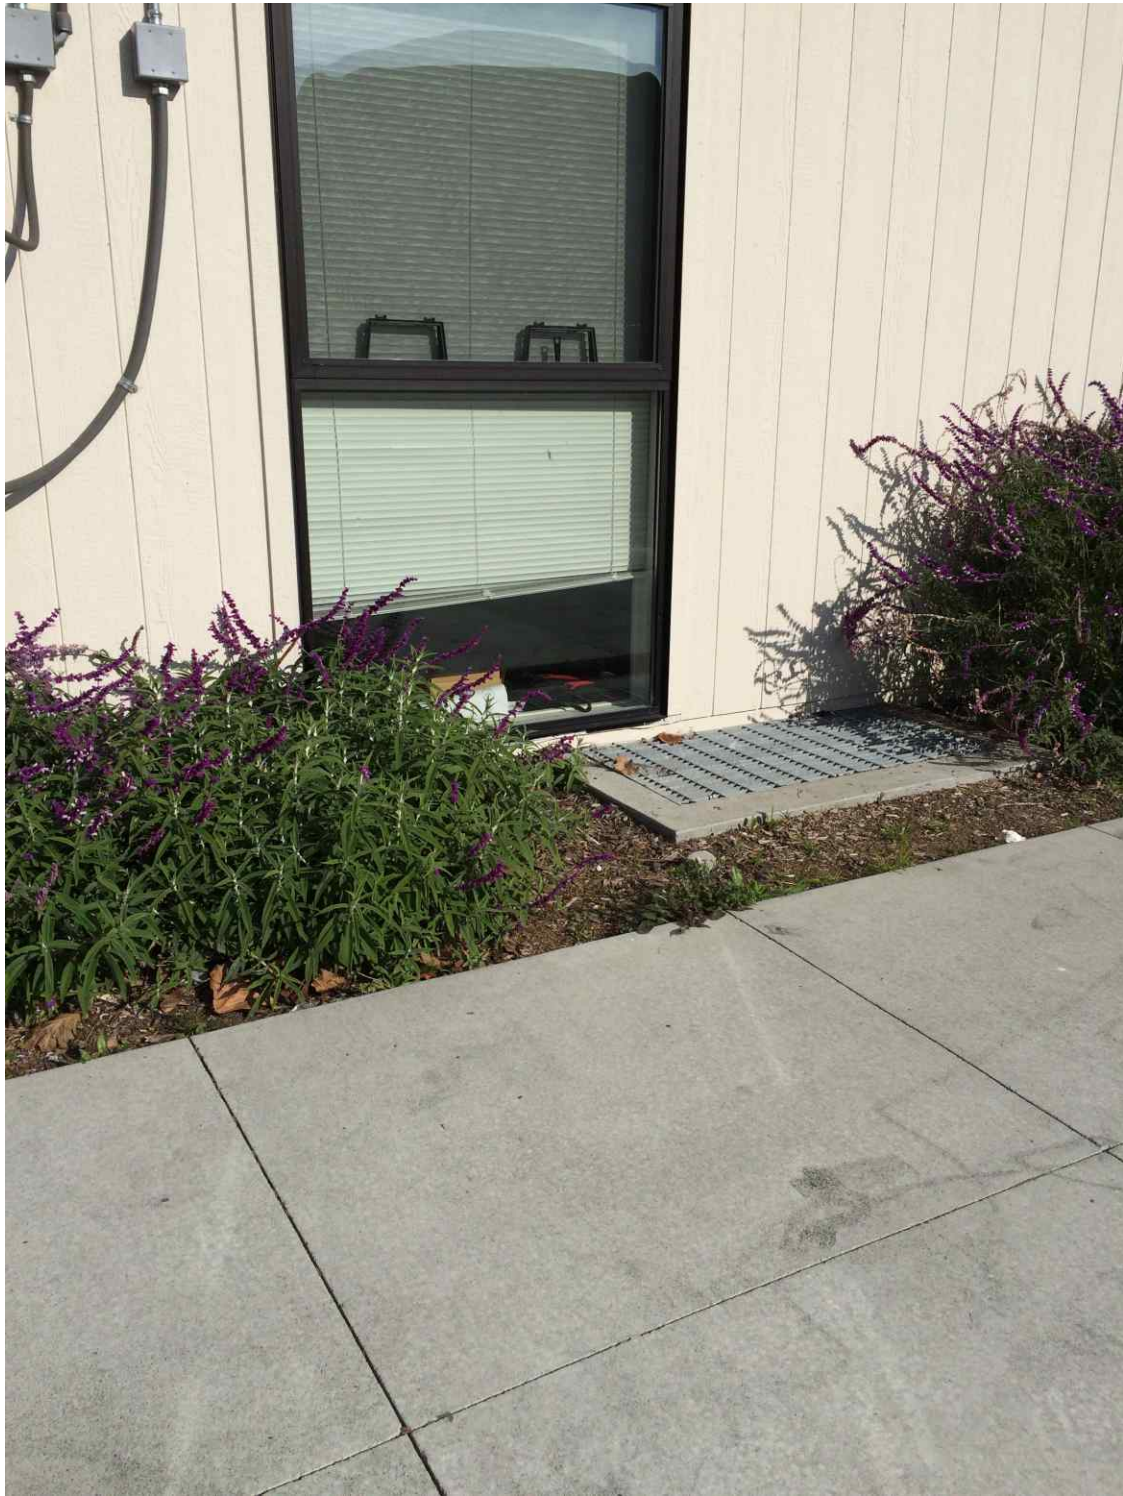
FIGURE
B-16

Landscaped-Planter Area Near Classroom

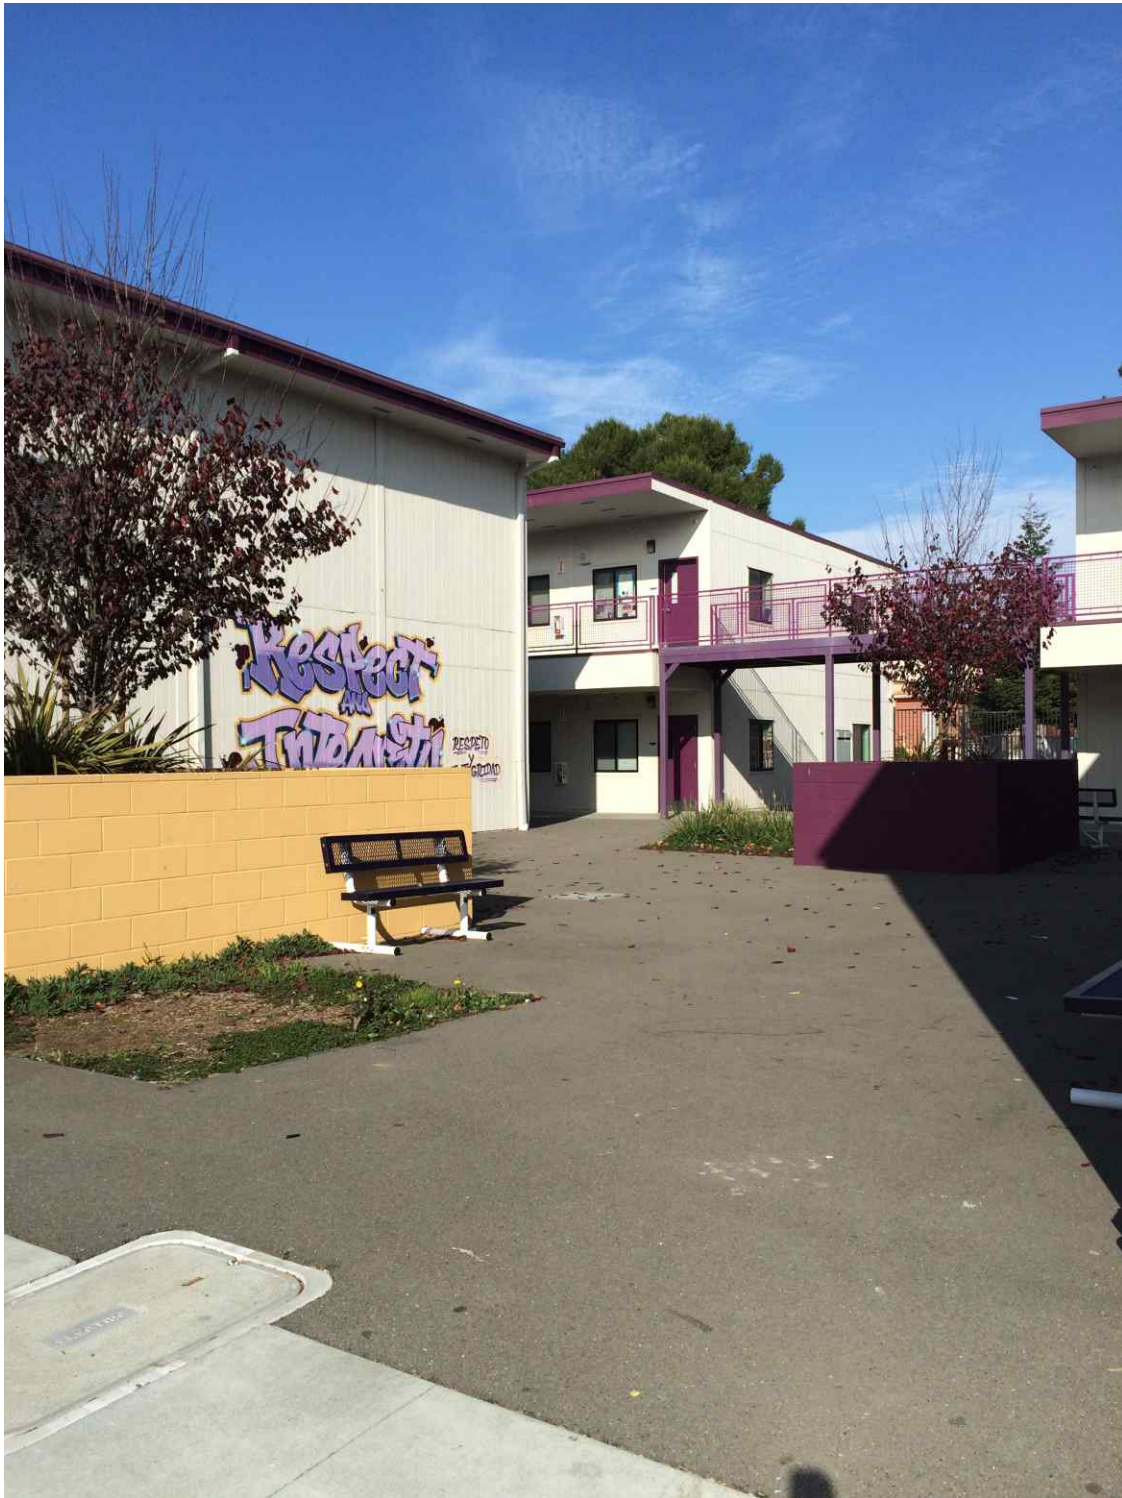
FIGURE
B-17

Pedestrian Walkway Area

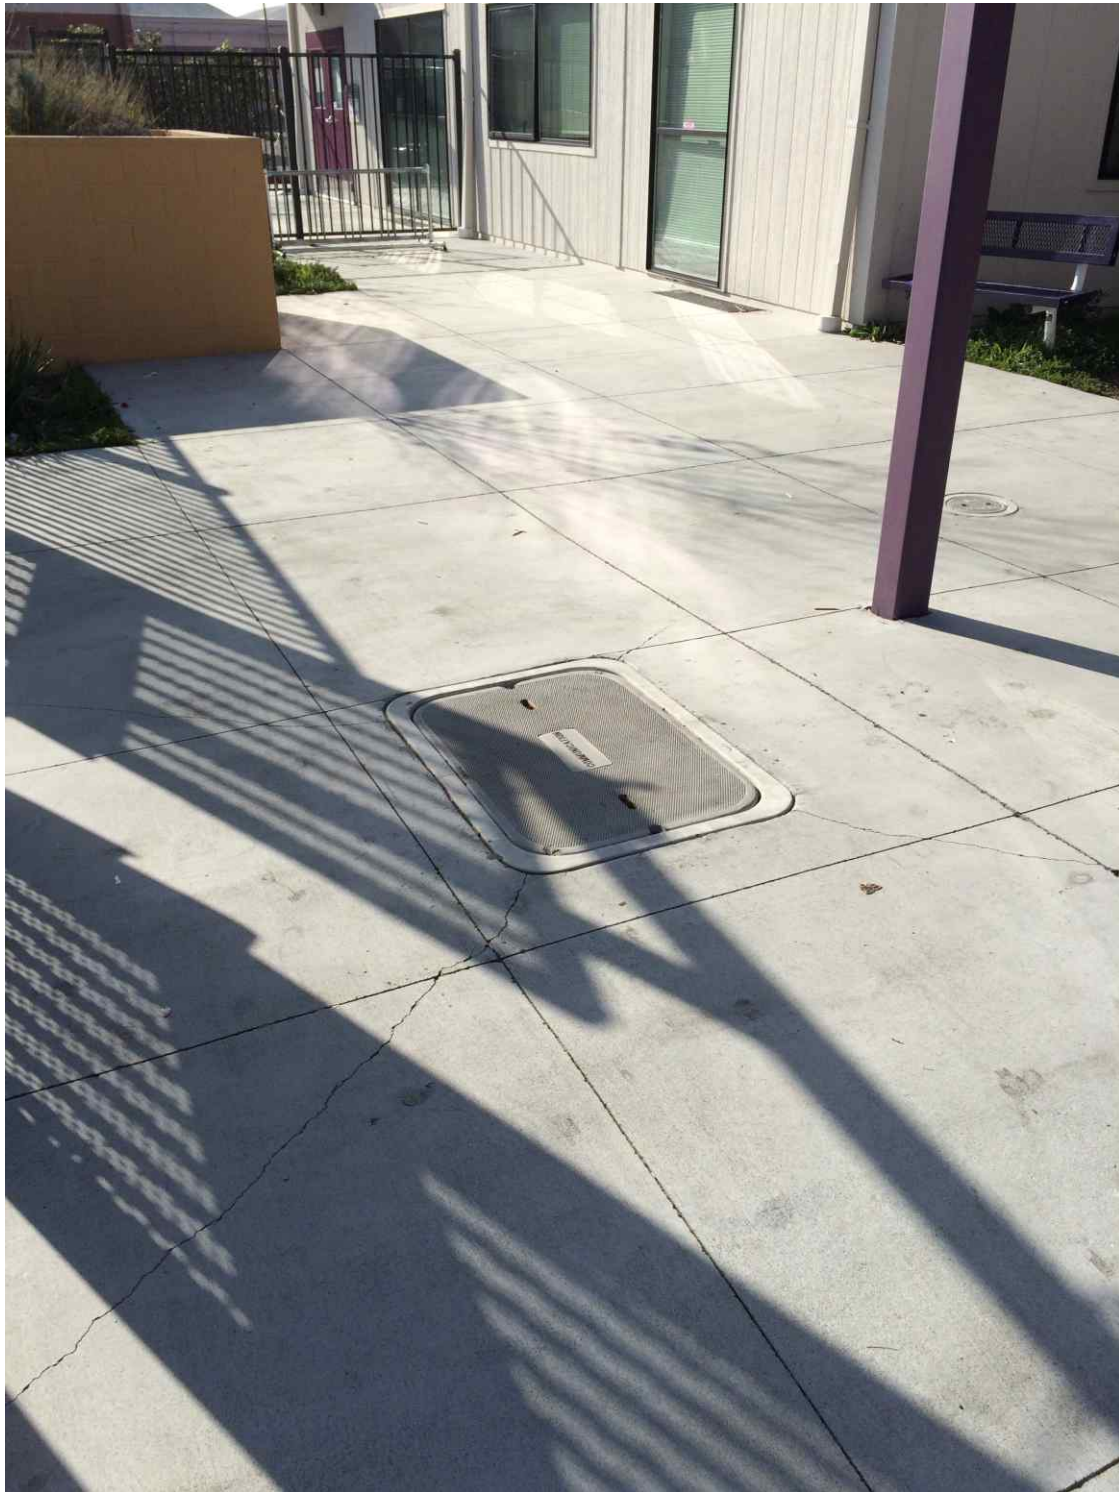
FIGURE
B-18

Minor Crack in Pedestrian walkway Area Near Office
